DEBRIS/ICE/TPS ASSESSMENT  
AND  
PHOTOGRAPHIC ANALYSIS  
OF  
SHUTTLE MISSION STS-32R

January 9, 1990

Gregory N. Katnik  
NASA/Kennedy Space Center  
TV-MSD-22

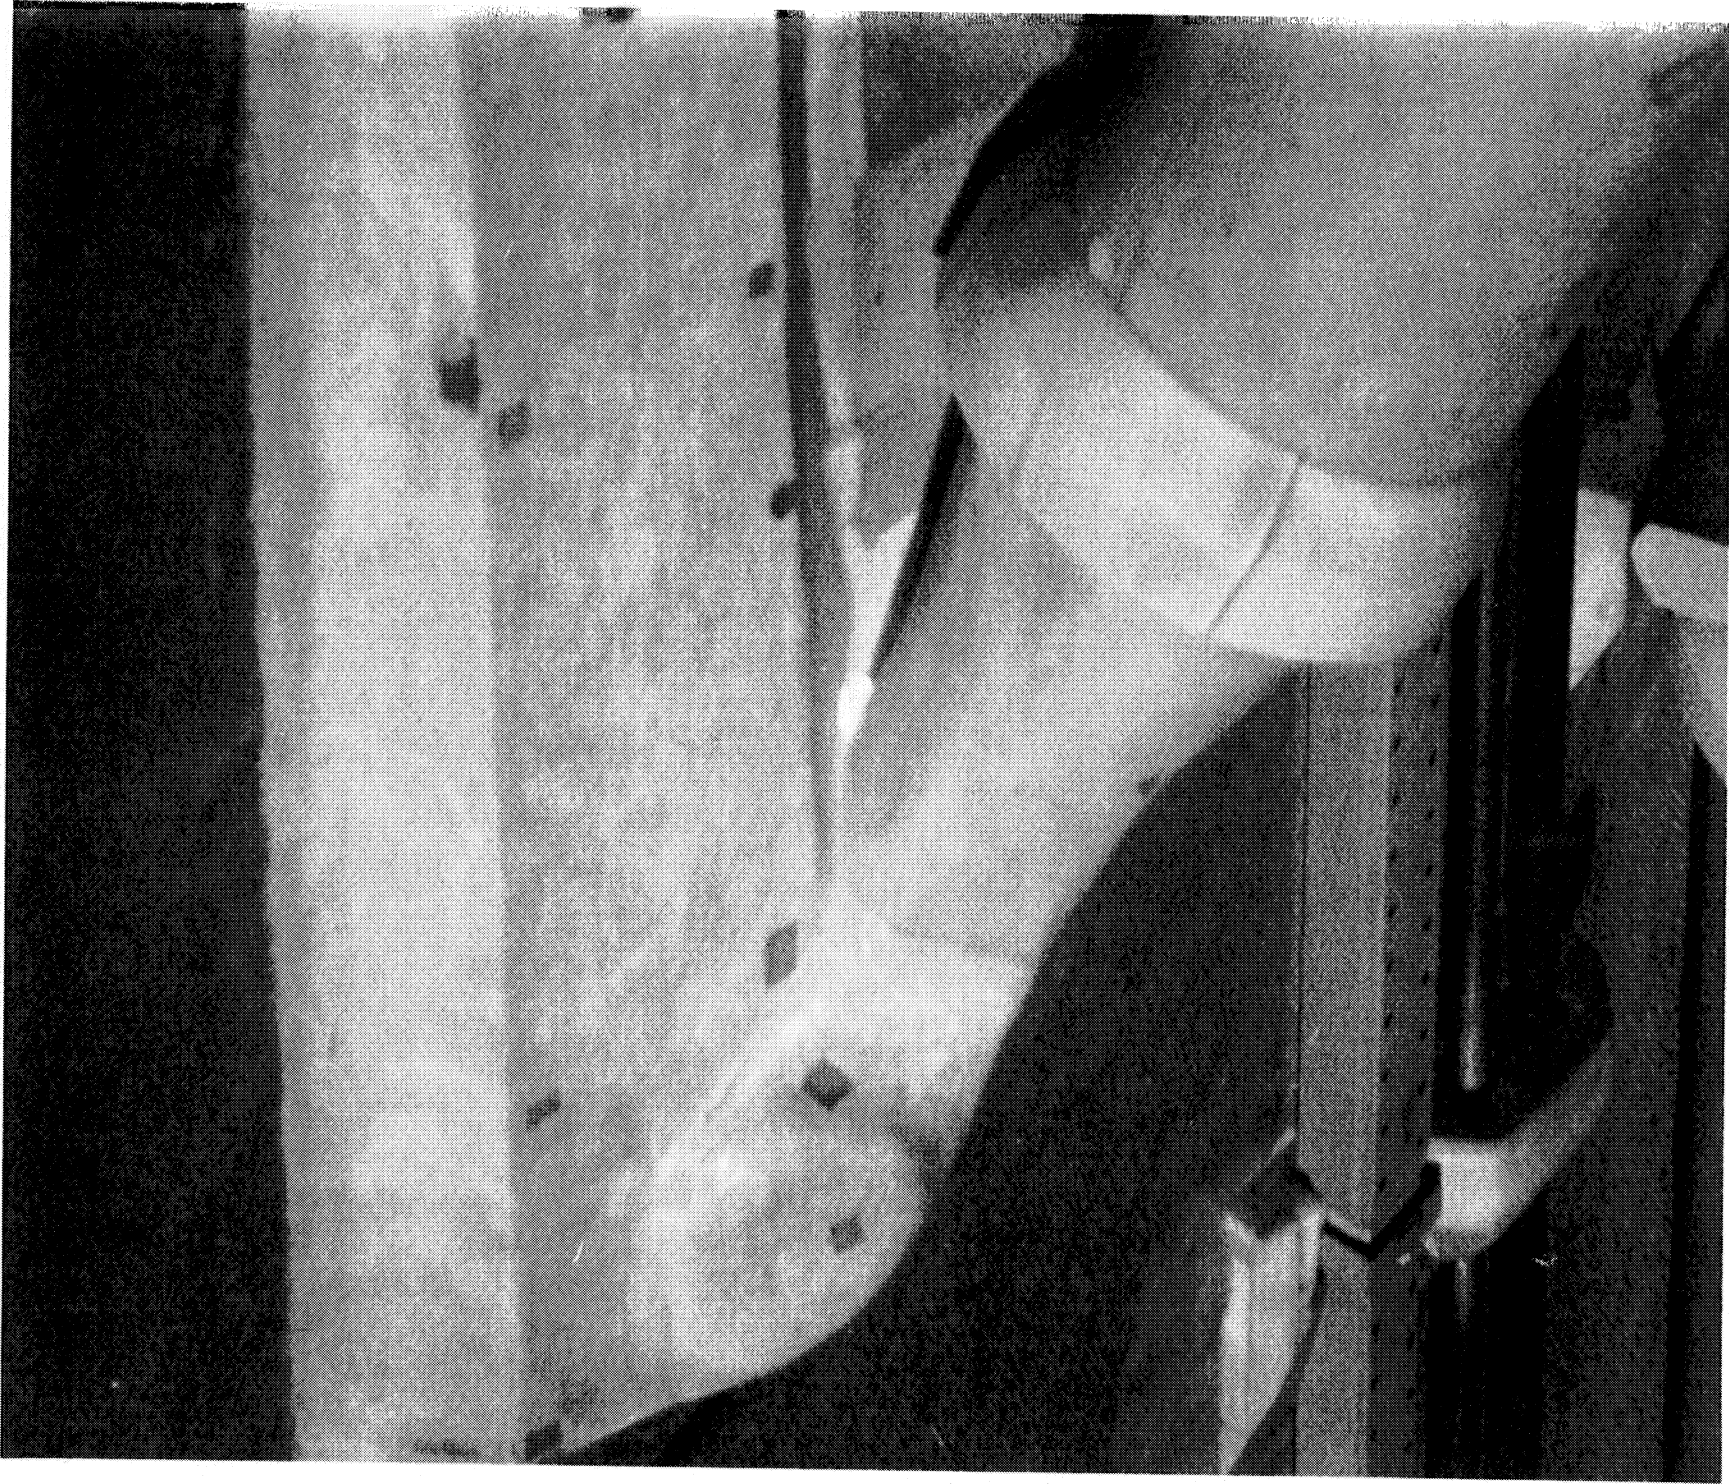
A small TPS crack caused a frost spot to form in the thrust  
strut-to-longeron interface

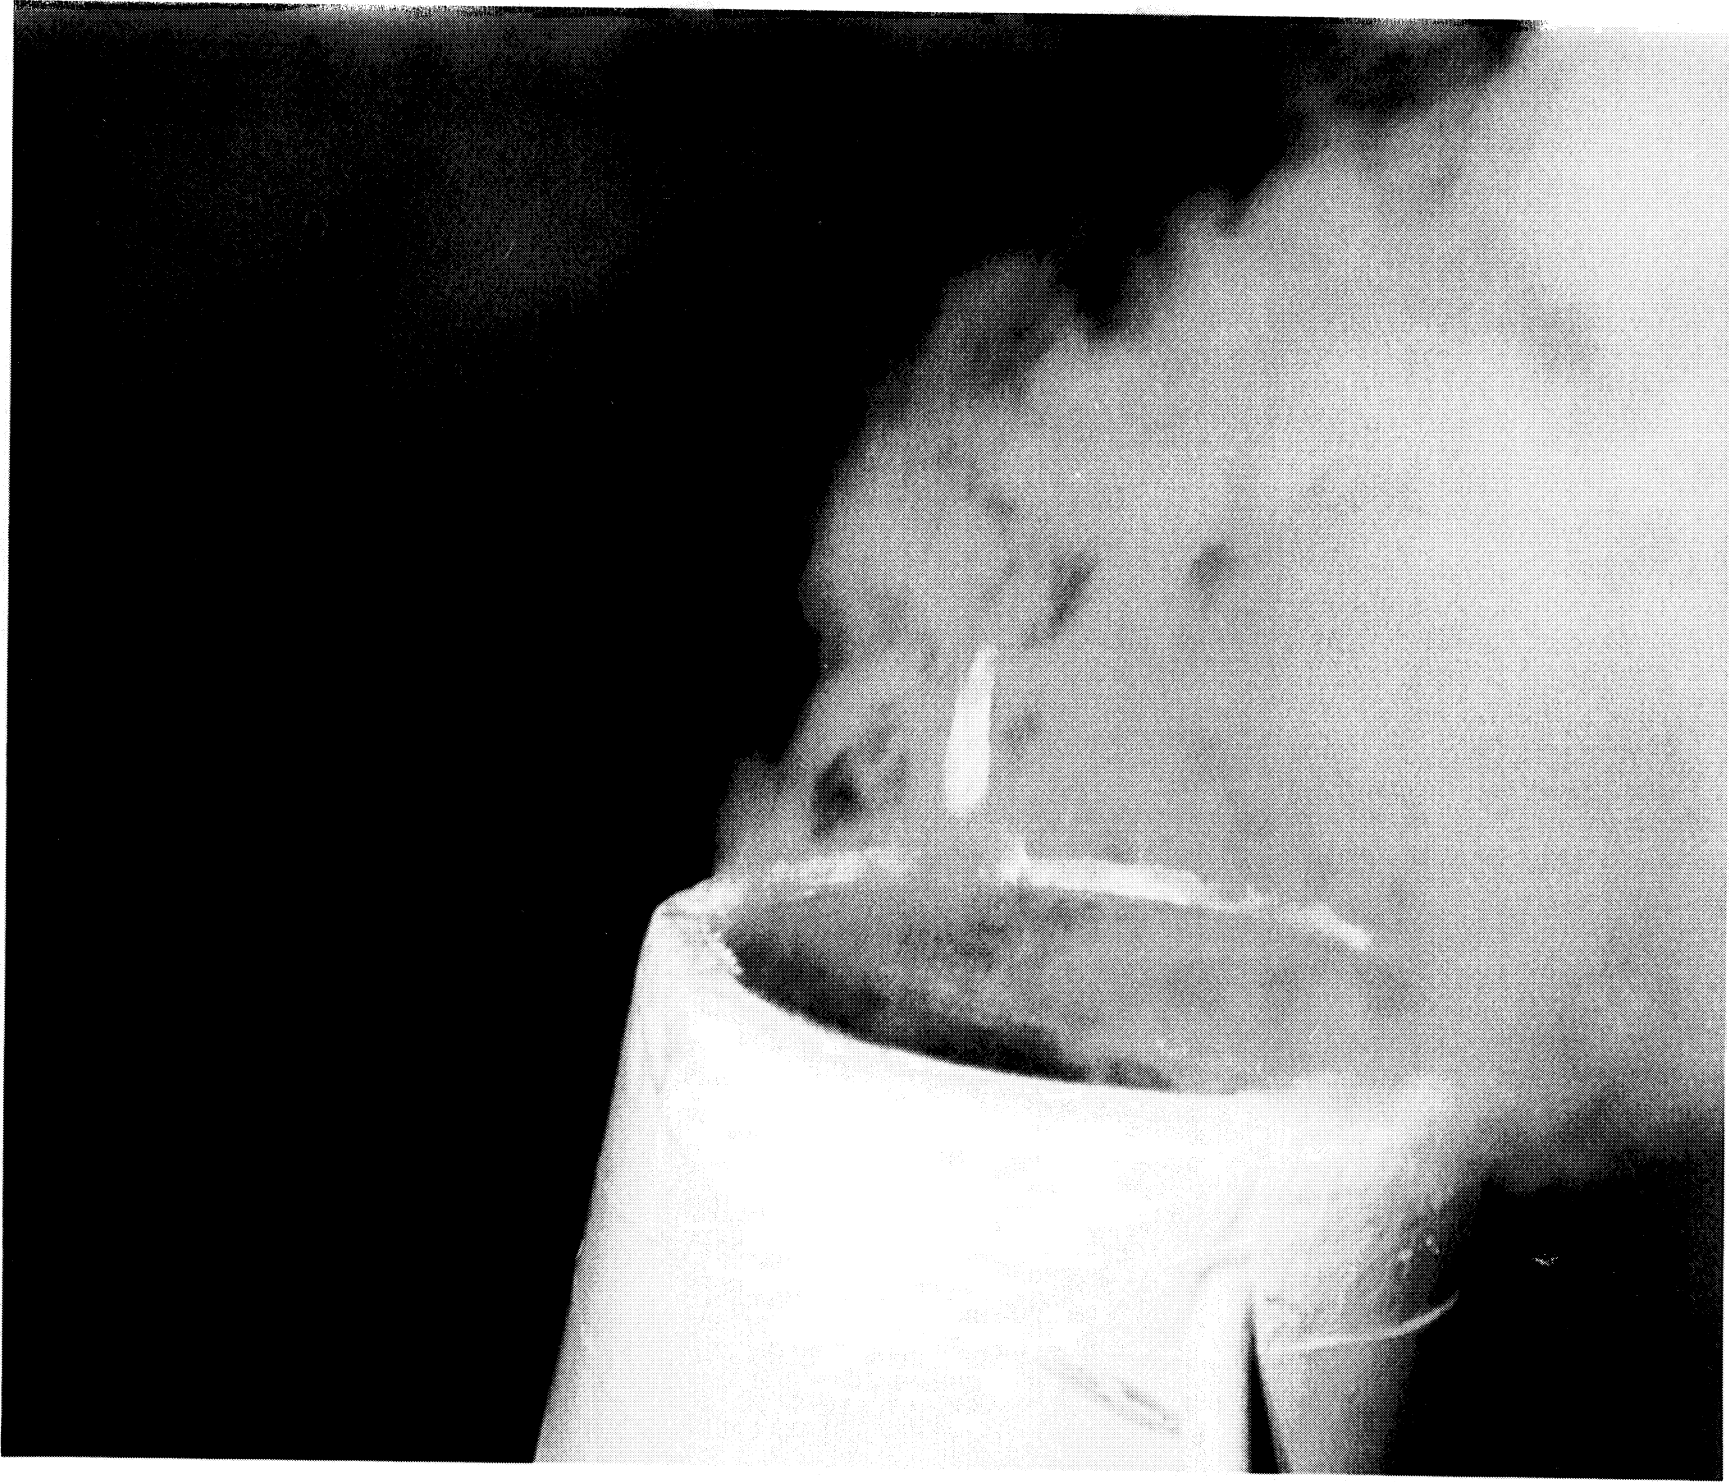
Omitting the hydro diverter on the north GOX vent duct caused  
dripping water/condensate to form 8-inch icicles

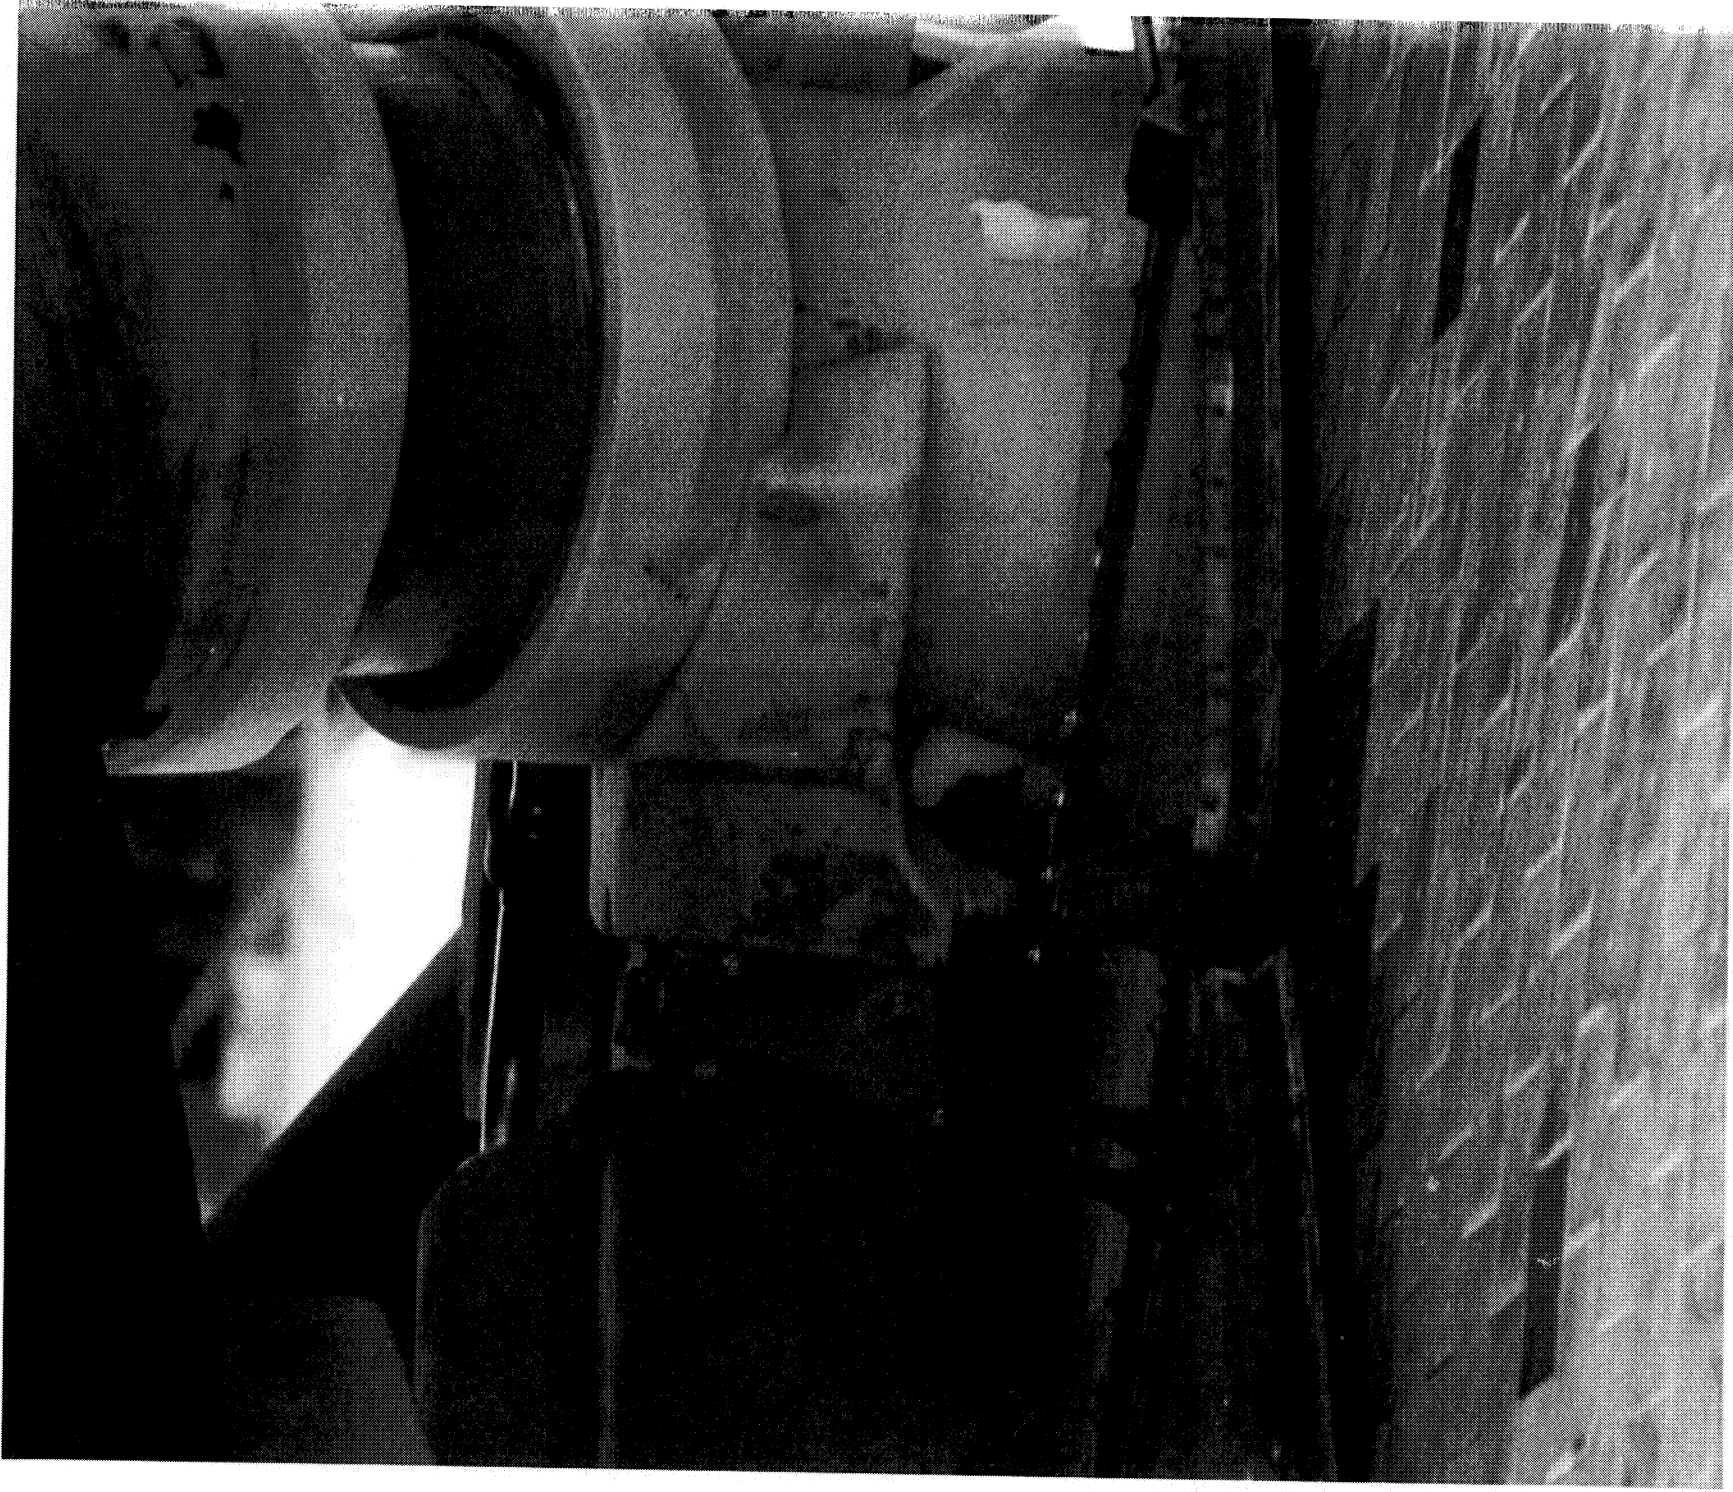
Although no ice/frost was present in the LH2 feedline bellows  
after drain, hard ice was still attached to the purge vents.

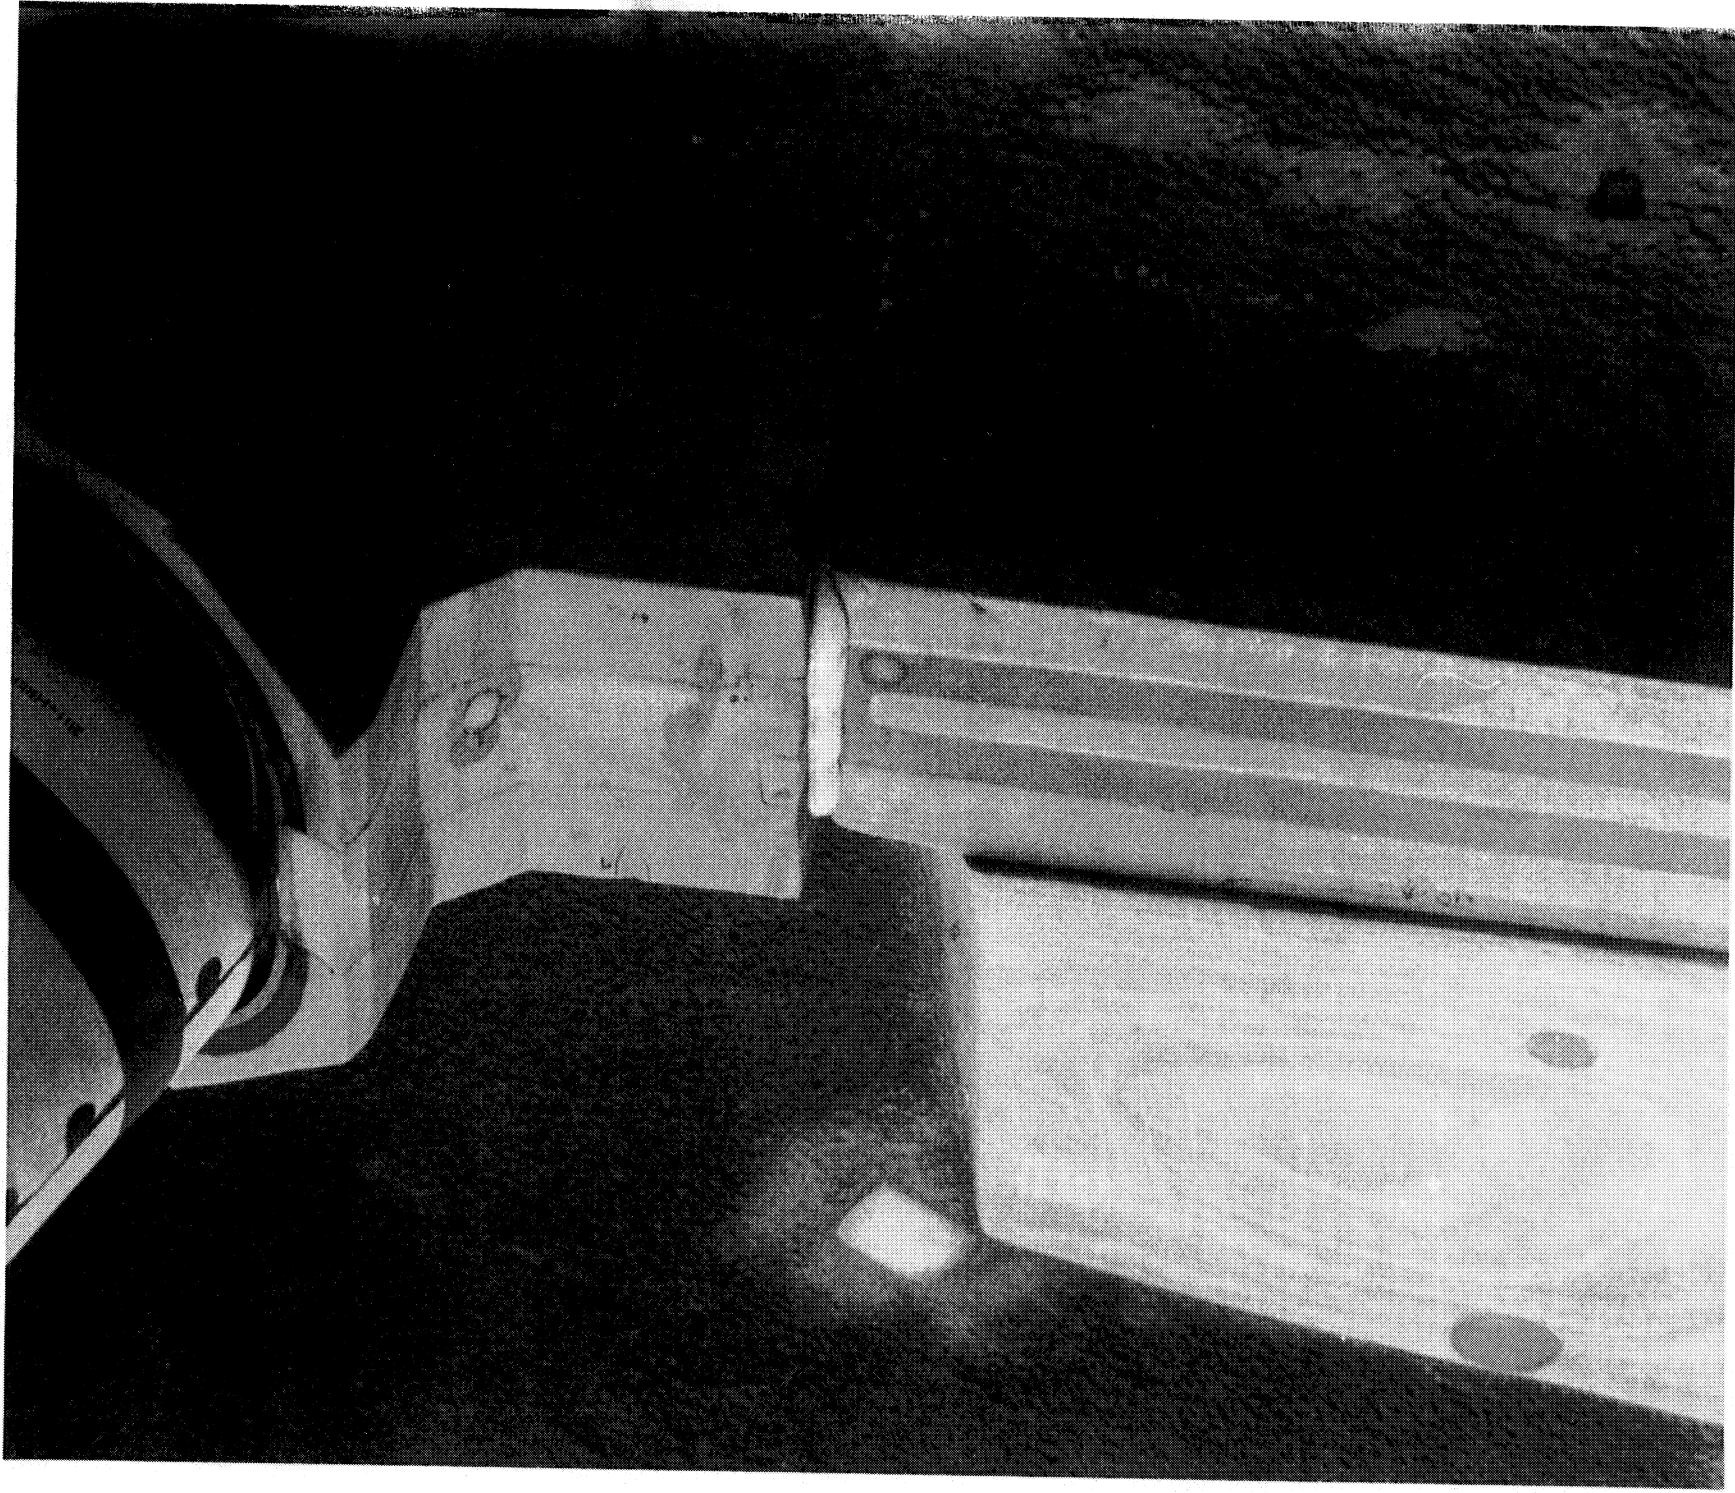
Hard ice had extruded from both +Y and -Y ET/SRB cable tray  
splices  
45

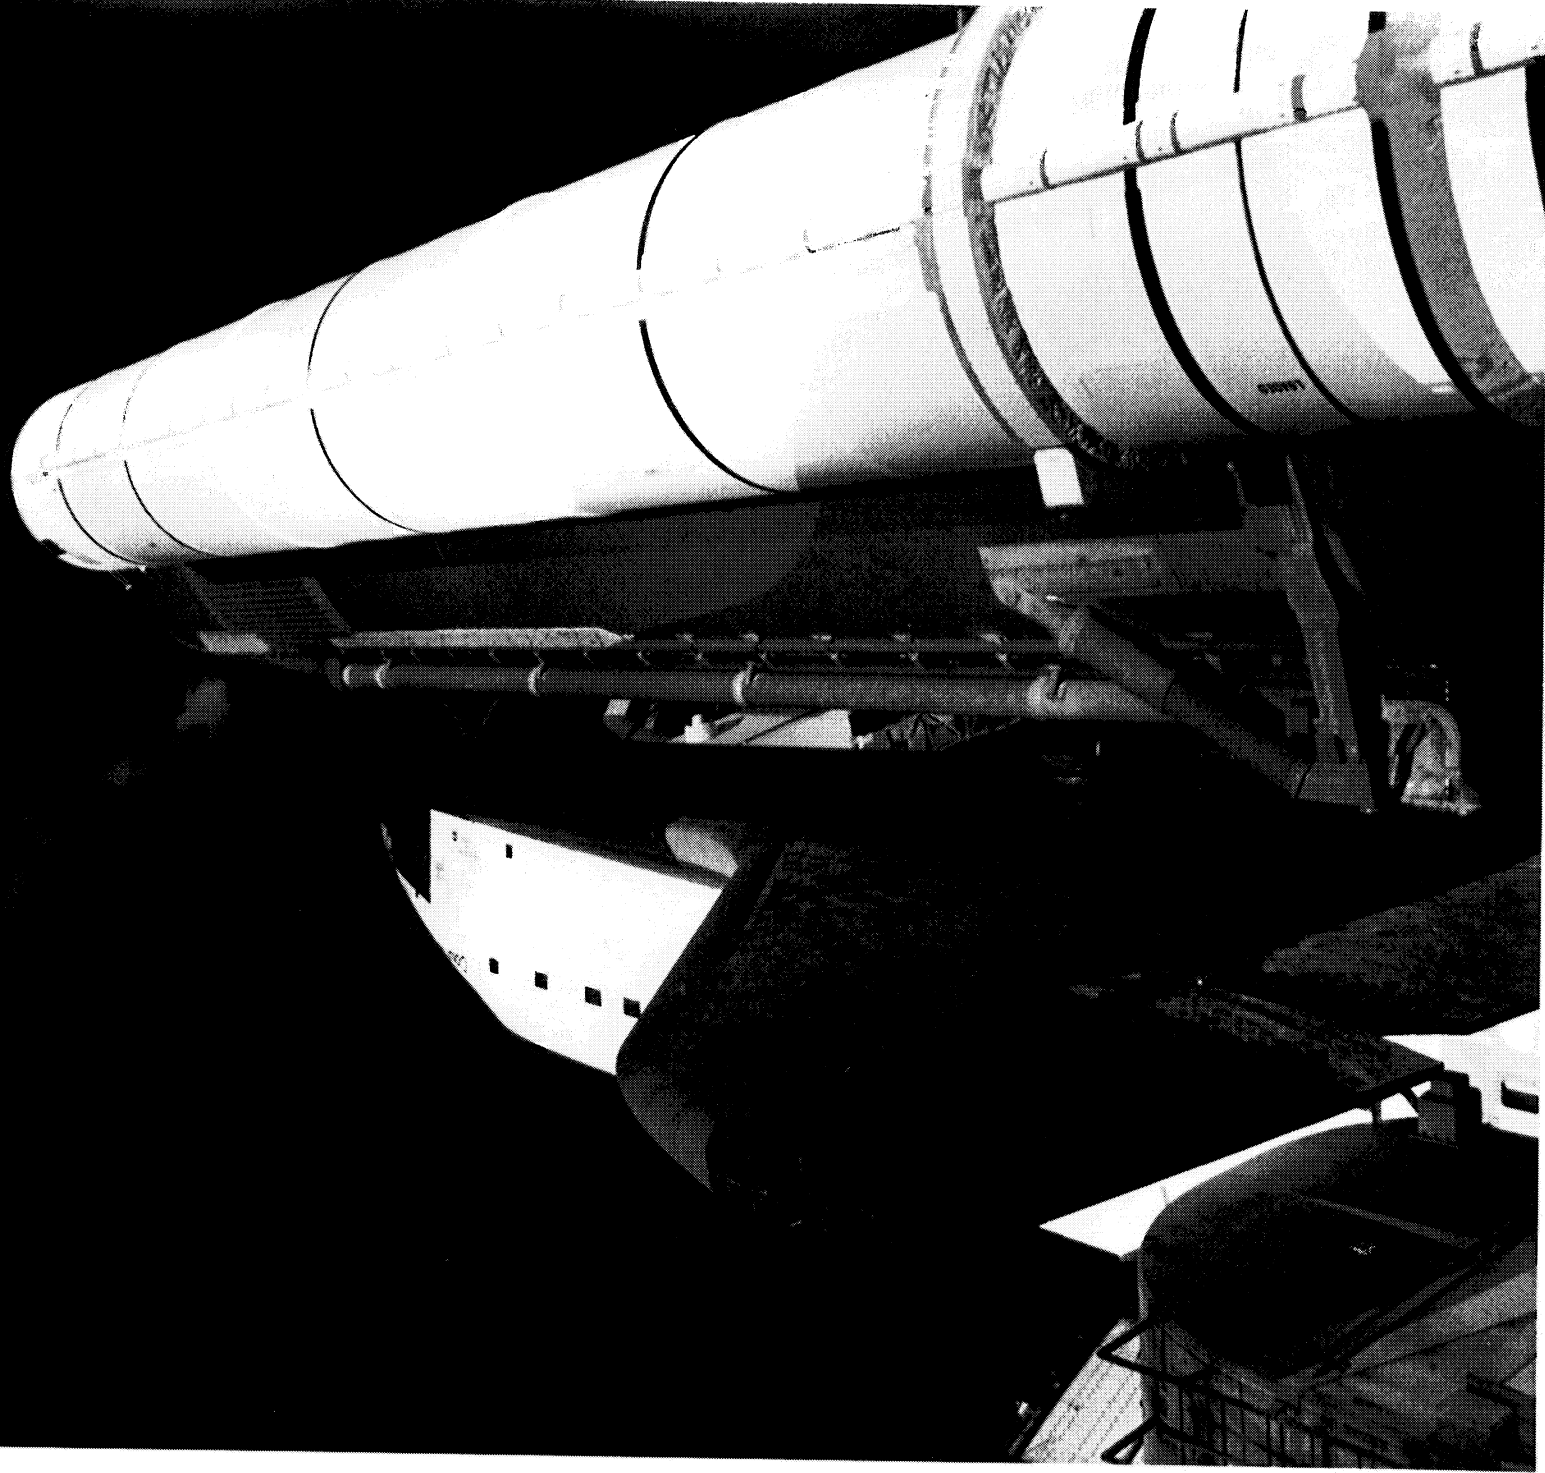
No ice/frost had formed on the acreage in the +Y+Z quadrant  
though a frost line formed along the PAL ramp

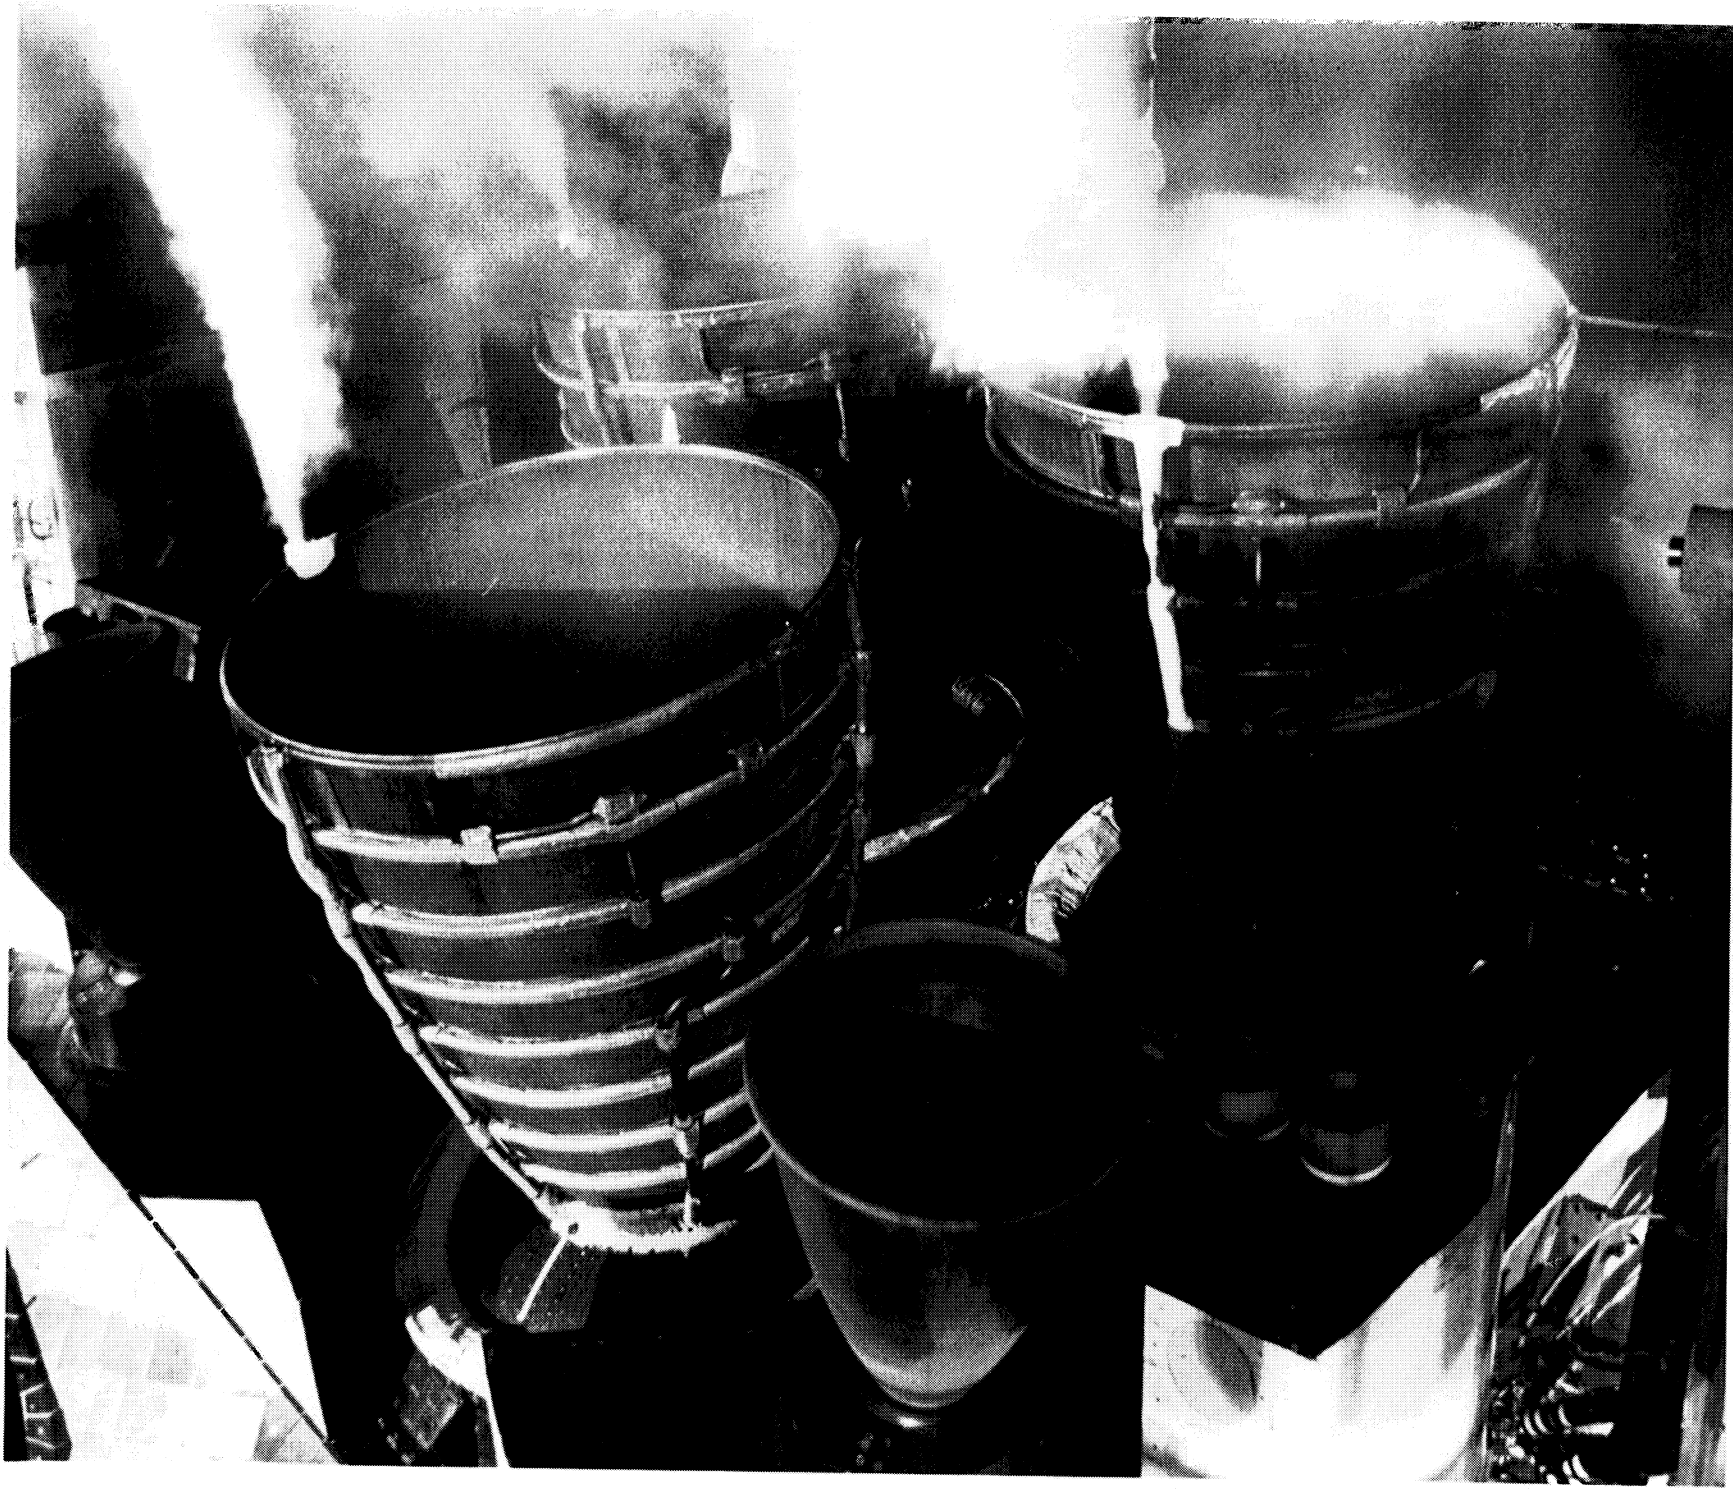
Overall view of the SSME's. Note ice/frost on the engine mounted heat shield interfaces and SSME #2 LO2 drain line

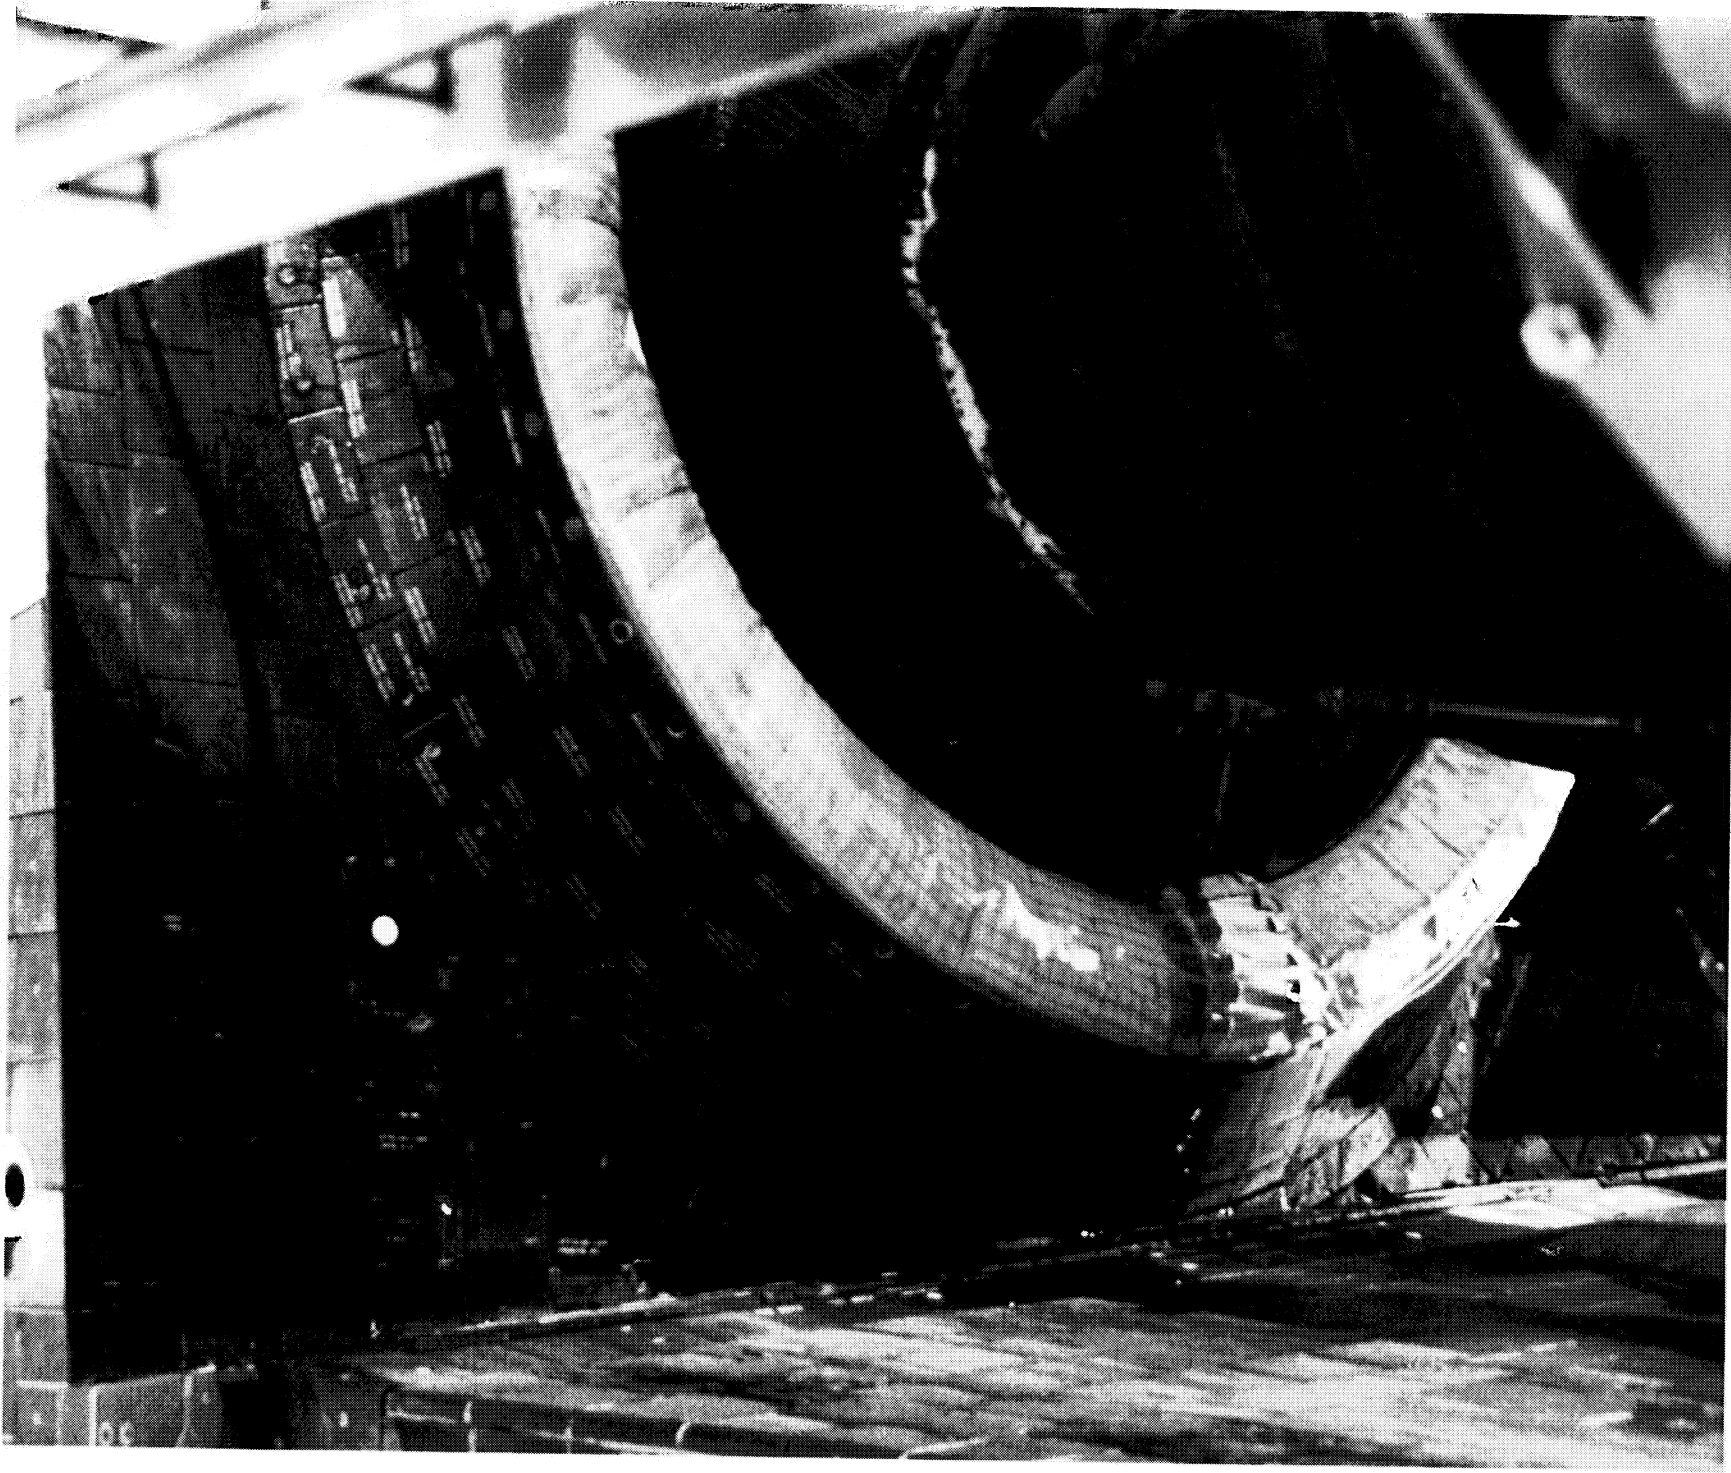
SSME #2 exhibits condensate on the engine heat shield and frost along the interface. Note frost spot on base heat shield vent.

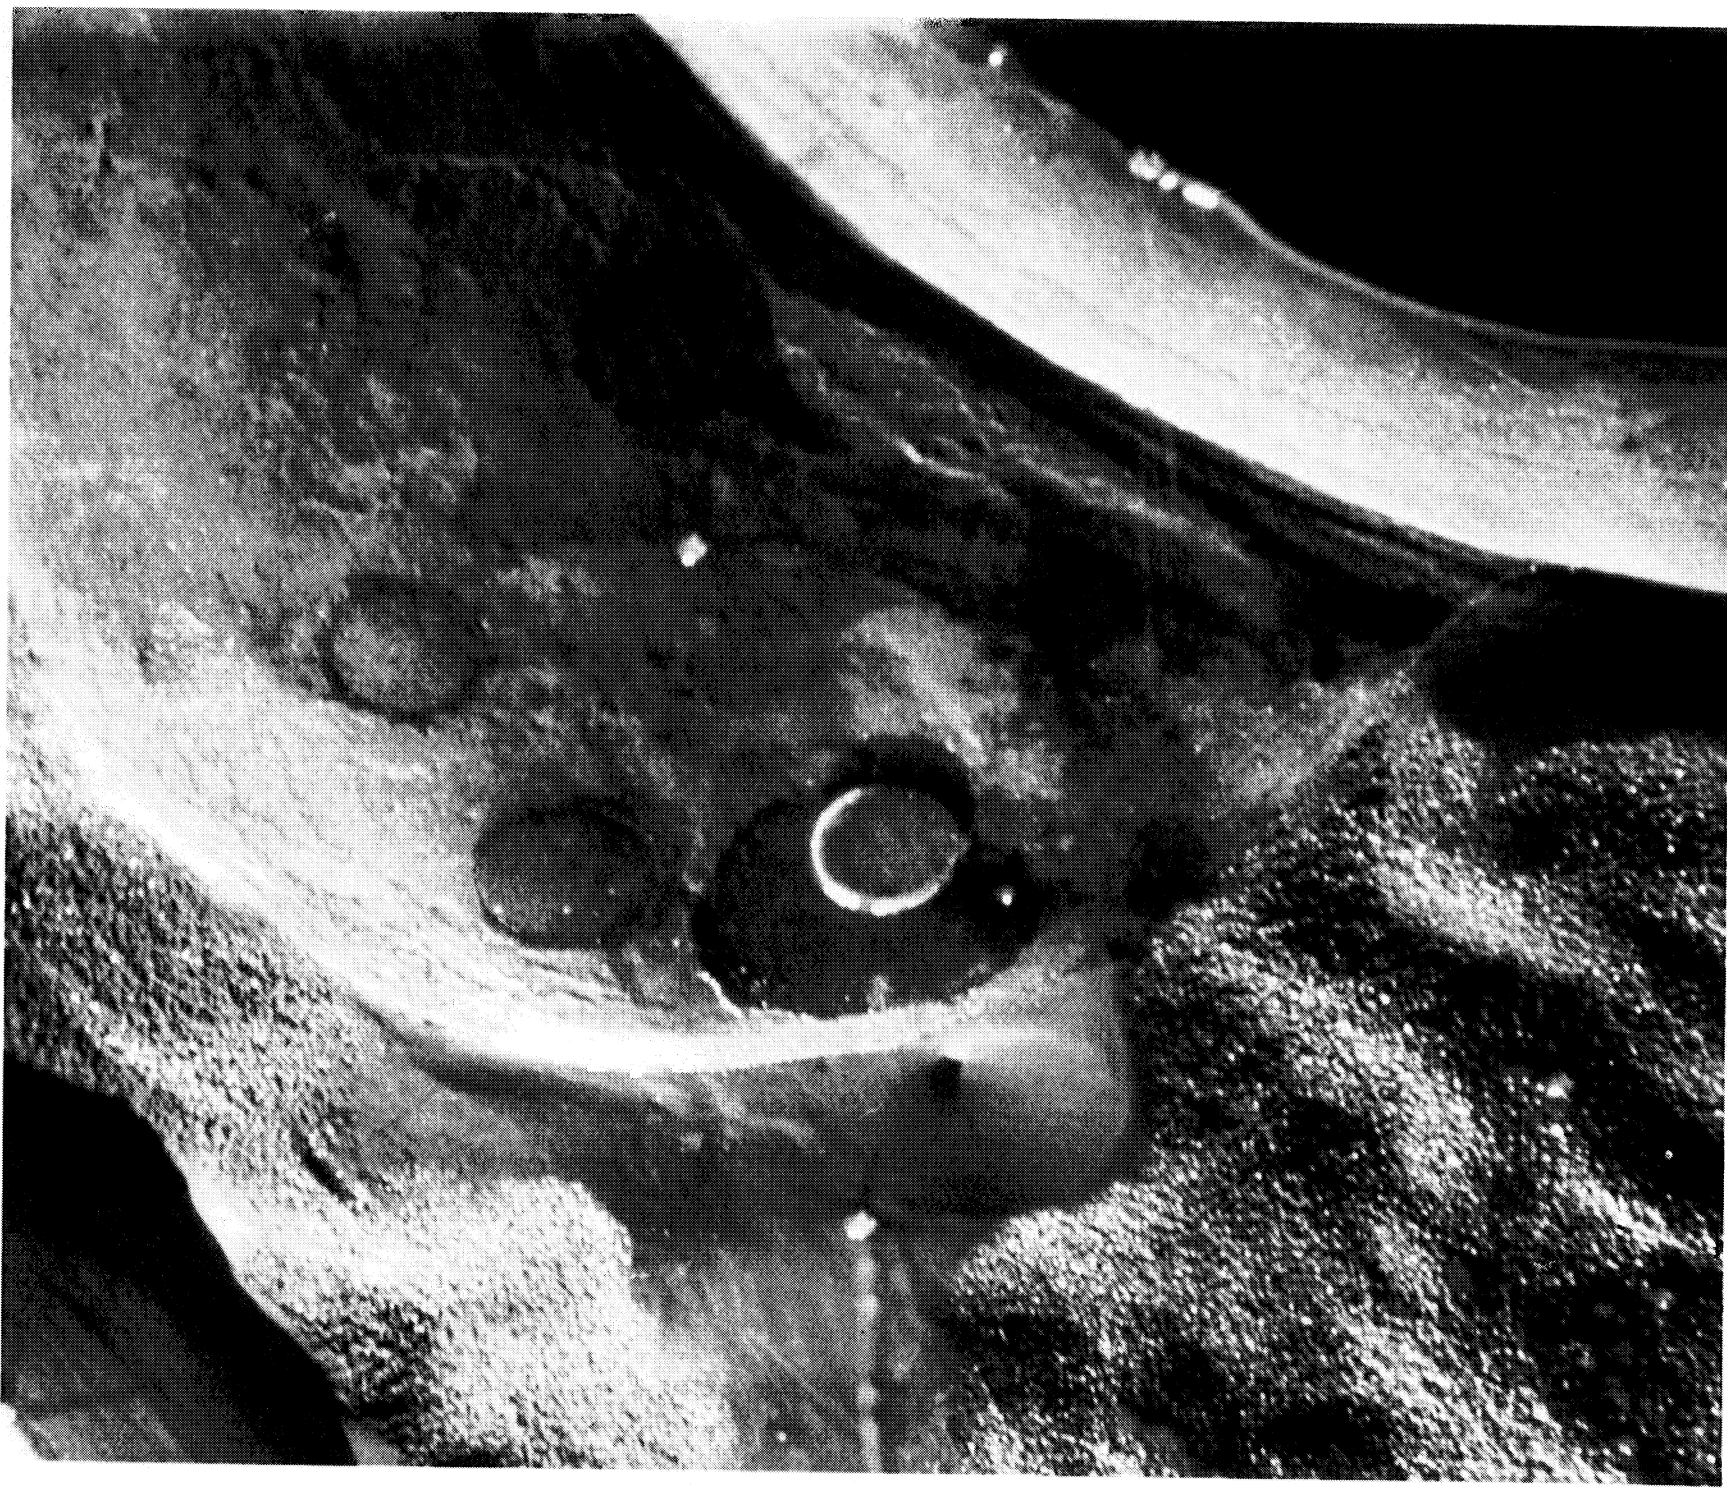
2 inches in diameter was protruding 3/8 inch. PR TS-0063 was taken and dispositioned with MRB approval to fly-as-is. Hard ice was present in the LO2 feedline bellows and support brackets. Light accumulations of frost on the LO2 ET/Orbiter umbilical were typical. The LH2 ET/Orbiter umbilical exhibited greater than average ice/frost accumulation. There were no unusual vapors emanating from the umbilicals or any evidence of leakage. The GOX vent duct hydro diverters from Pad B were installed on Pad A prior to cryoload and prevented icicle formation. Twelve Ice/Frost console anomalies were documented and found acceptable for launch per the LCC and NSTS-08303. At launch, the ET ice condition was well within the data base for ice formation.

Previous 3-inch diameter repair on LH2 tank aft dome apex  
begins to protrude due to cryopumping

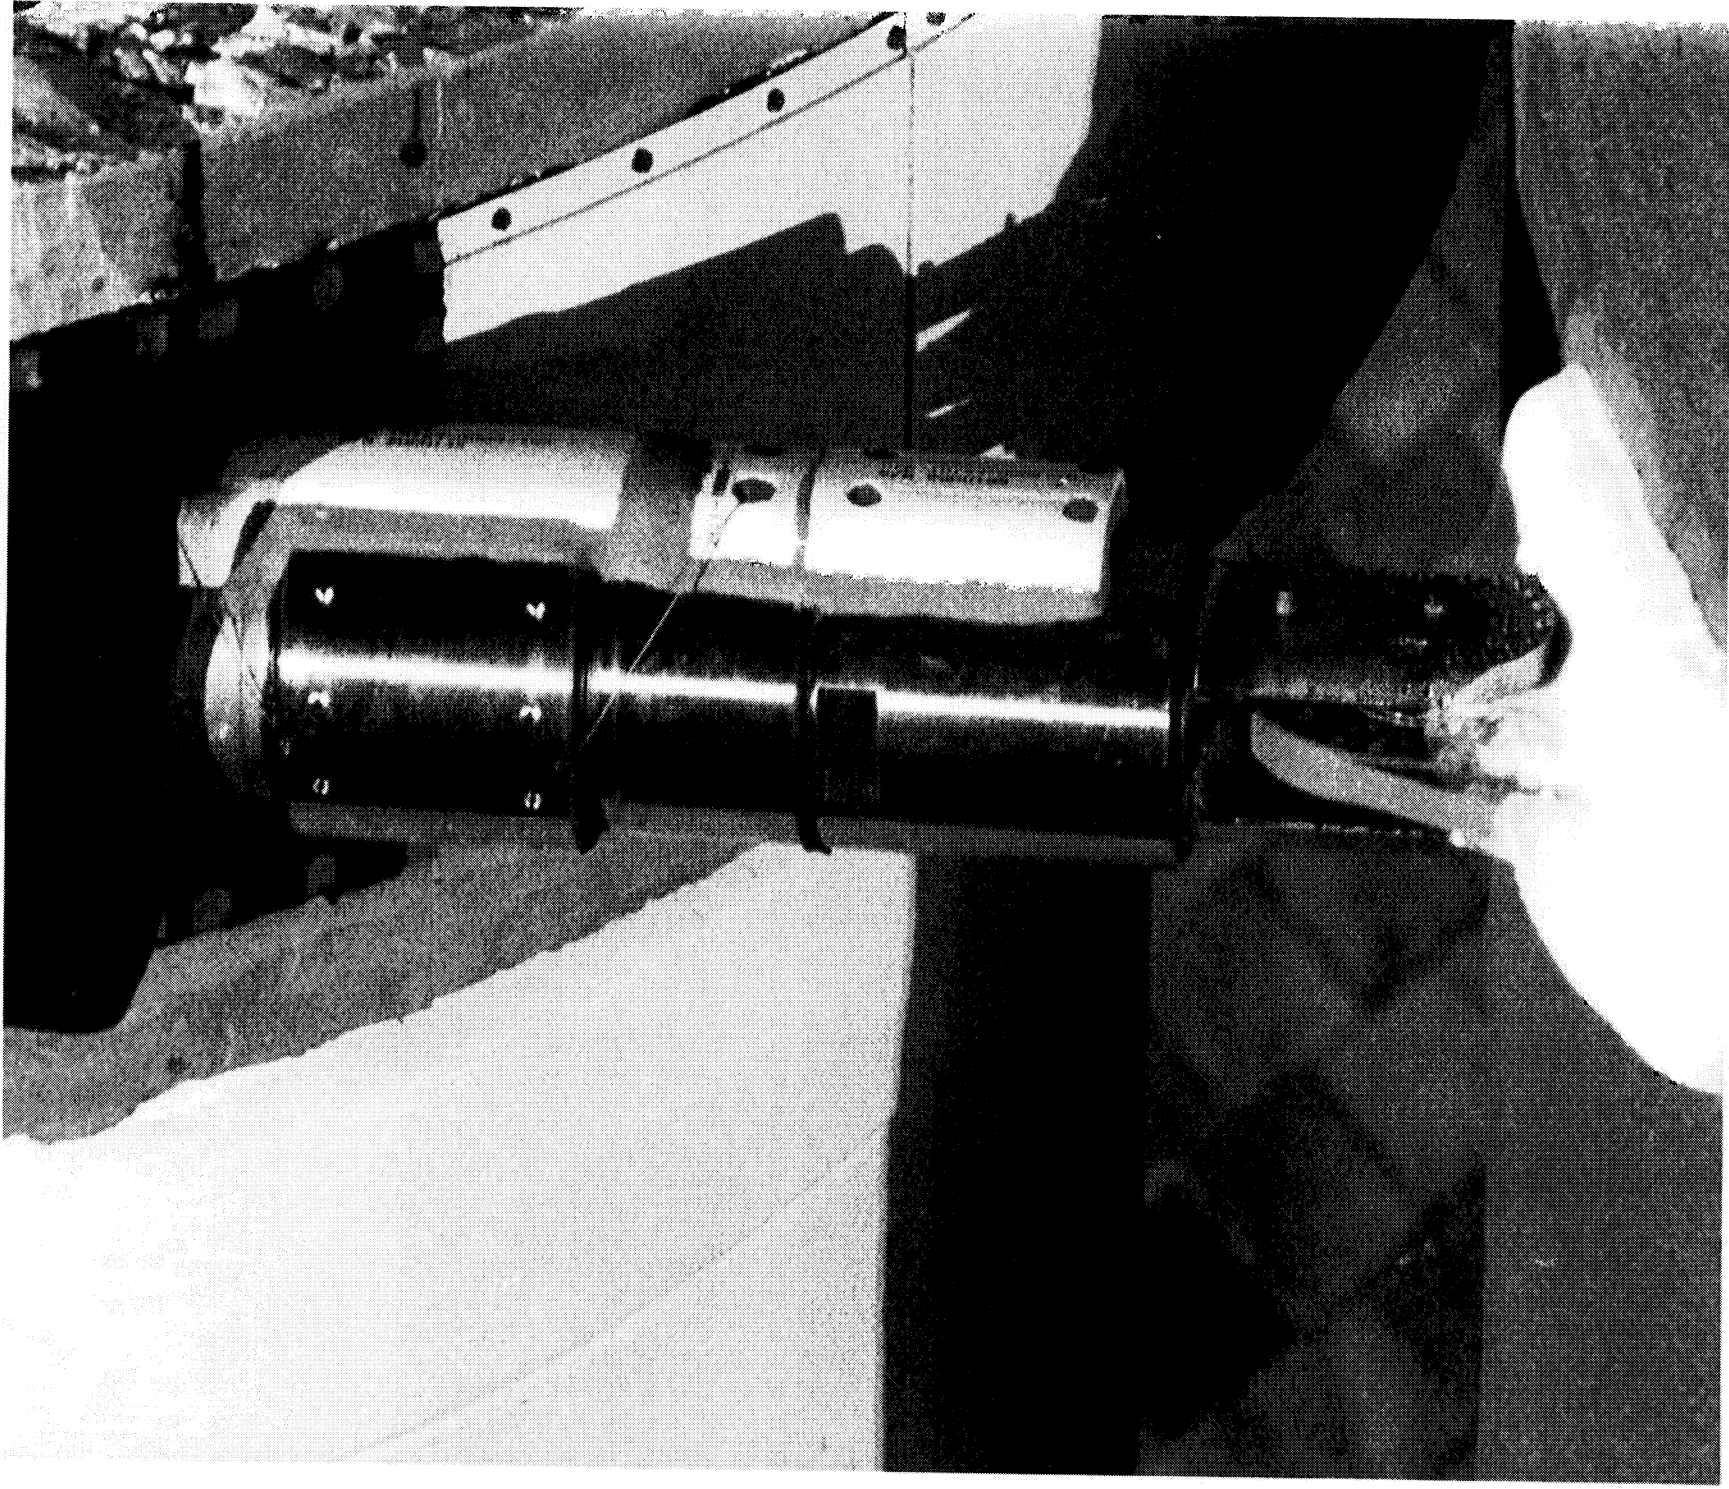
Although ice/frost covers the EB-7 fitting, only condensate is present on the lower strut clevis
